Citroën ID/DS High pressure pump overhaul

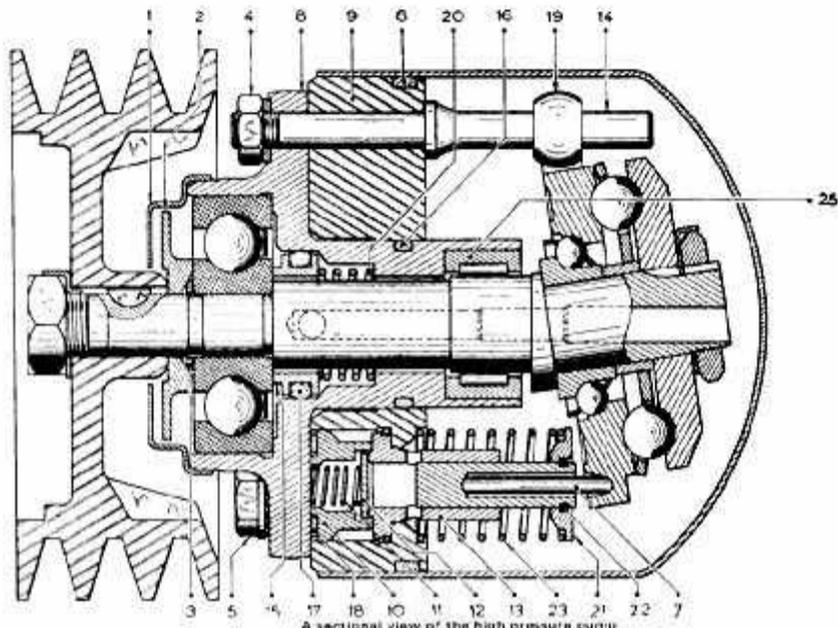
A sectional view of the high pressure pump
 1. Dust cover 2. Thrust washer 3. Seal ring 4. Nut 5. Screws 6. Seal ring 7. Pushrods 8. End plate
 9. Pump body 10. Valve guides 11. Springs 12. Valves 13. Cylinders 14. Rods 15. Distance piece and seal assembly
 16. Seal ring and plate 17. Seal ring 18. Seal rings 19. Olive 20. Springs 21. Cups 22. Clips 23. Return springs
 24. Needle bearings

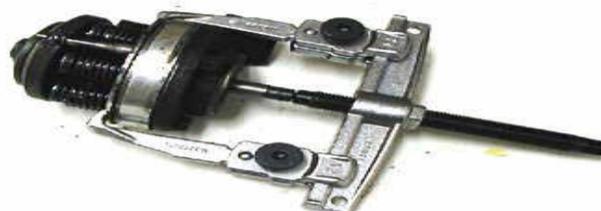
In the past Citroen sold a tool for removing the pump housing

(2282T) which I do not have. Therefore I started with making a tool to remove the pump housing. The problem was that in the pump body screws were used with a diameter of 8mm but a thread pitch of 1mm in stead of the common 1.25mm for Metric M8 screws.

For this reason I used the lathe to produce three screws, diameter 8mm, total length 8cm with on one side a thread with a pitch of 1mm and the other side with a pitch of 1.25mm. Furthermore I did bent a strip of 3cm wide and 4mm thick to fit around the pump body. Additionally a piece of scrap plywood (11x10cm 18mm thick) served as the top.

Remove the nut from the pulley and remove the pulley, dust cover (carefully) and the steel plate as well as some screws and the small triangular mounting plate. With the three homemade screws fitted and the strip put in place, the plywood was brought in position as shown on the photo. Then gradually the screws were tightened, one by one, pressing the housing off the pump body.

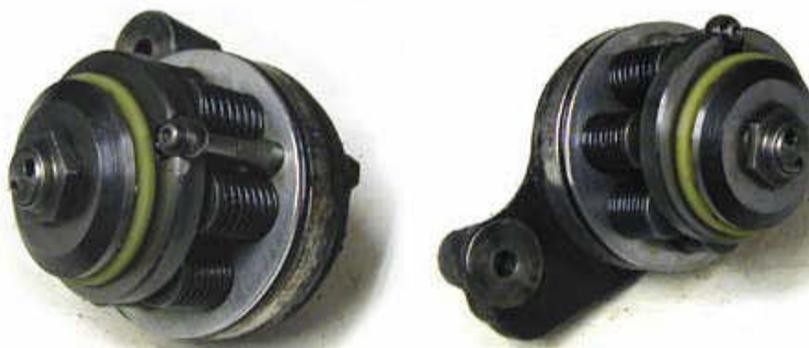
After removing the pump housing it was obvious that the pump was not in a good condition. It was extremely dirty. Furthermore two mechanical problems showed (see photo). One cylinder was stuck in the low position, not delivering any pressure. More seriously however was a crack between two cylinders in the aluminum pump body. This is a common problem with these pumps. Always check this first before putting effort into the rest of the disassembly. For me it was clear that I had to use another pump for the overhaul.

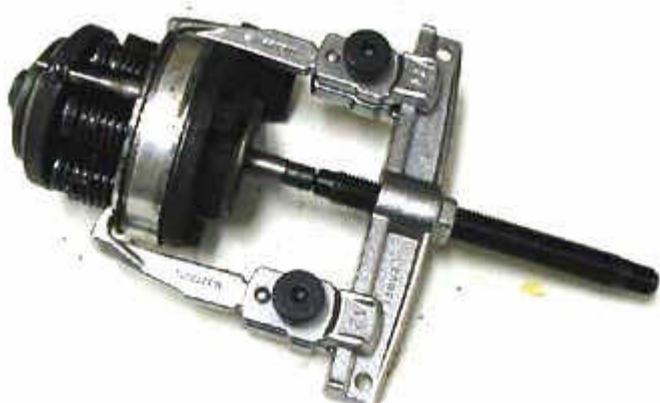
I started over again with a different pump. This pump had always run on LHM and was in a very good condition. The wear of the pump parts was not excessive and the aluminum pump body was in a very

good condition.

I used a pulley extractor to remove the spindle from the pump. Be careful not to lift the pistons out off the cylinders in this stage as the pistons and cylinders are couples and should be kept together. I also kept the pushrods with the cylinder in order not to end up with the tedious process to determine the accurate length of the rods as described in the repair manual. All other parts can be mixed.

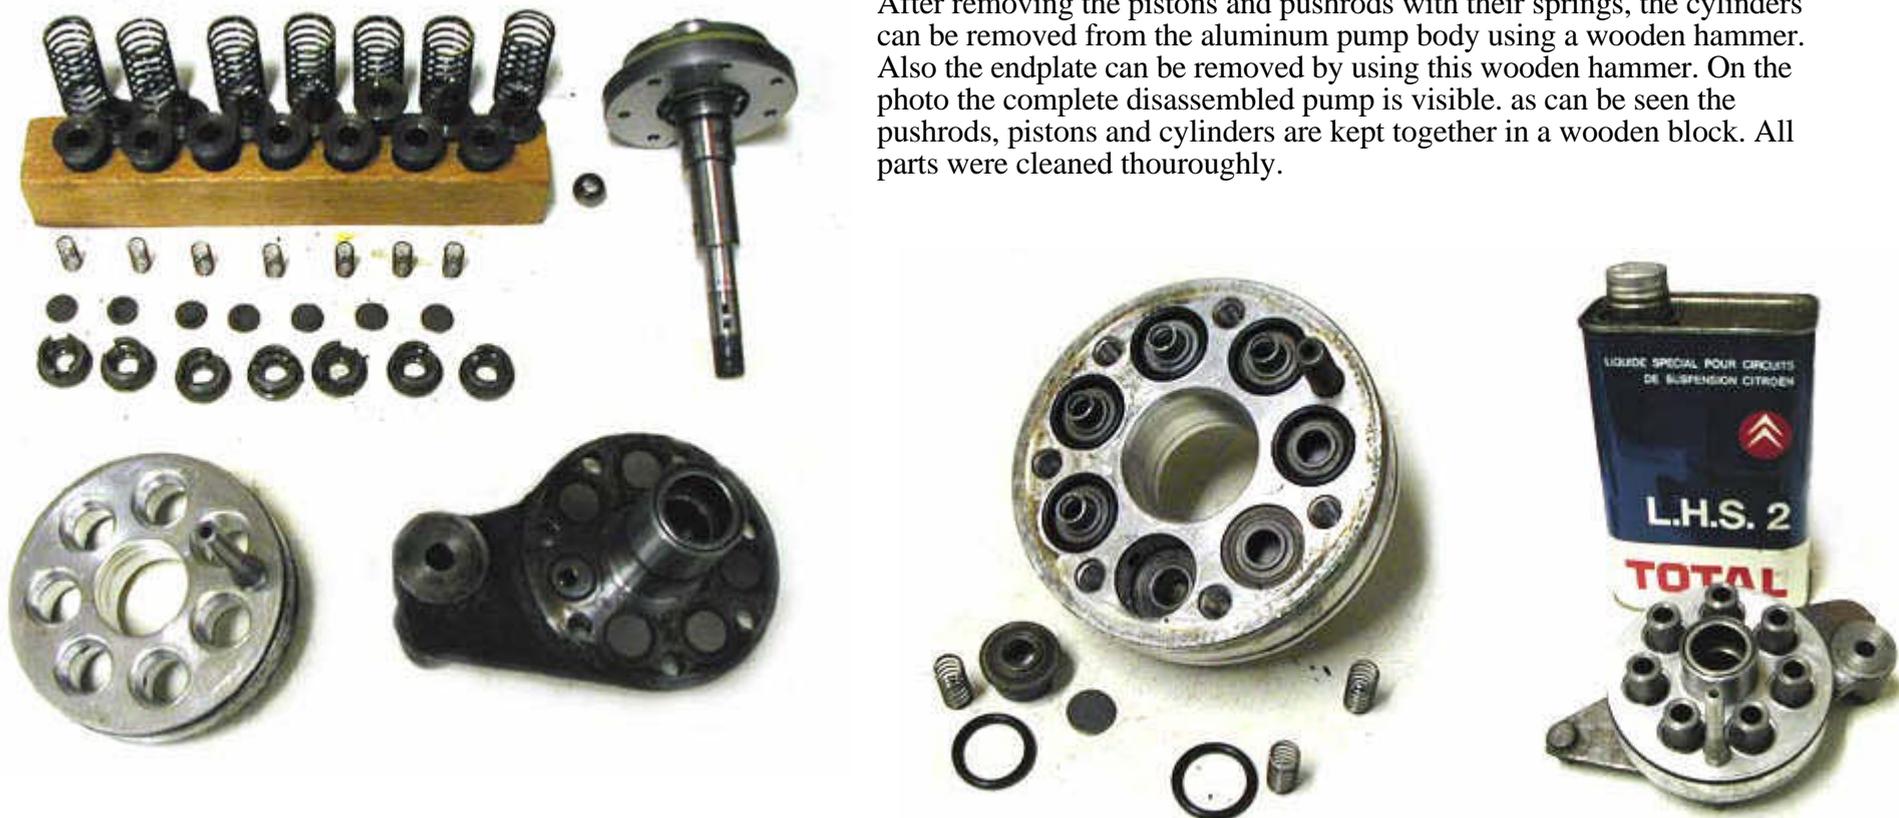
After removing the pistons and pushrods with their springs, the cylinders can be removed from the aluminum pump body using a wooden hammer. Also the endplate can be removed by using this wooden hammer. On the photo the complete disassembled pump is visible. as can be seen the pushrods, pistons and cylinders are kept together in a wooden block. All parts were cleaned thoroughly.

After the cleaning new seal rings were inserted in the aluminum block and the cylinders were put in place at their original positions after using some LHS (or LHM if the pump should be operated with LHM) to make it easier to insert them. After that the valves, valve guides, springs and seal rings were put in place again. On the endplate the seal ring was also replaced. The endplate was put onto of the pump body and screws were tightened with 3.5 mkg (34.335 N.m = 25.32 ft.lbf = 303.8 in.lbf).

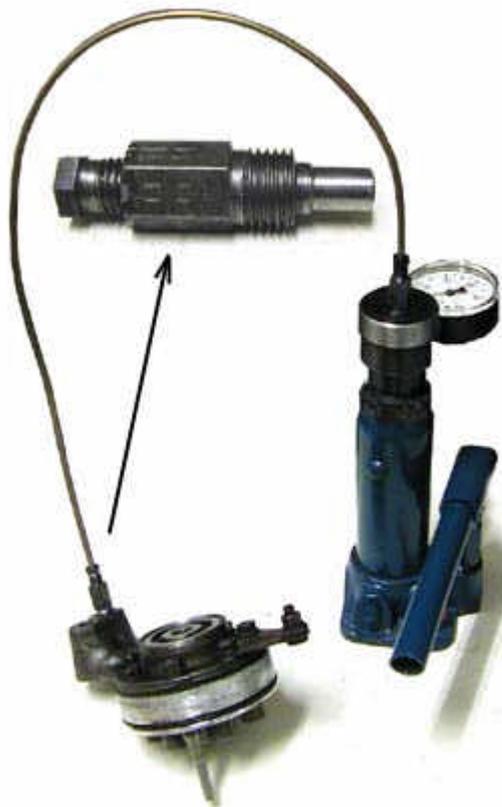
After the assembly of the pump body this assembly can be tested for leaks. I connected the pump using a small adapter I made (as can be seen in the photo) so that I could use a standard hydraulic pipe (4.5mm). The pressure was produced using the [sphere tester](#) in combination with an adapter to be able to connect a hydraulic pipe. During the testing some LHS fluid leaked out off some cylinders due to valves not closing perfectly. Personally I think this is not dramatically. I carefully checked the seals between the pump body and endplate. These should not leak any fluid as this will cause problems when the pump is mounted.

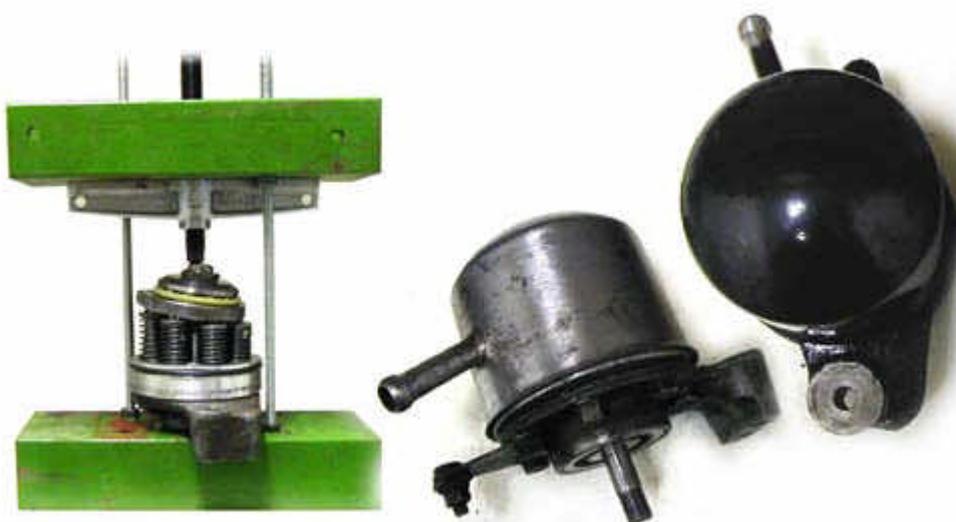
The next stage is to press the axle in place. I did not have a proper press for this so I produced a temporary press using some scrap iron (see photo) in combination with parts

of the pulley extractor. This worked fine for pushing the axle in place. I used the same press and a wooden cup to press the pump housing in place. Take care that the fluid inlet is positioned correctly as shown on the photo.
