The restoration of 'Snoopy' a 1966 Citroën DS 21 Pallas

Charles Vyse November 2001

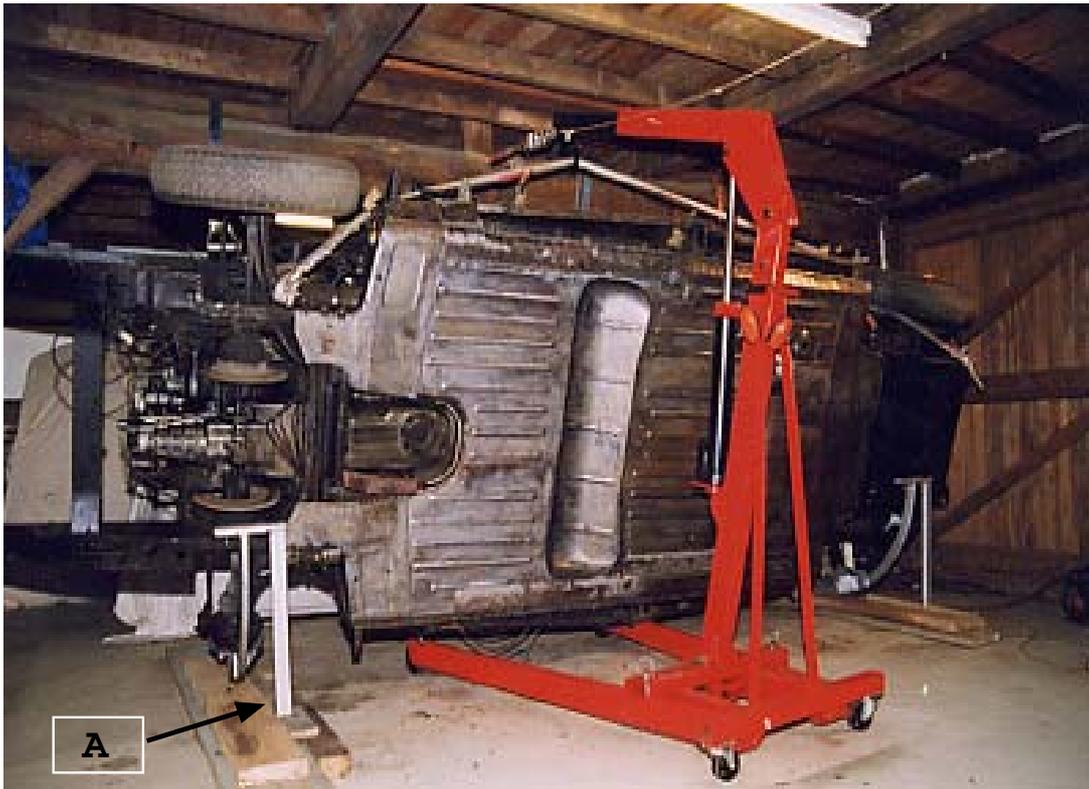
After stripping off the body panels and interior, the car was put on a car roller - you can see the two curved pieces on which the car is rolled. In theory the car can be rolled over by 5 men. I didn't have '5 men' - so used an engine crane. This was attached to a tow rope tied to the front and rear suspension arms and the crane used to roll the car over. The piece marked 'A' slots in after the car is rolled and prevents the car rolling back.

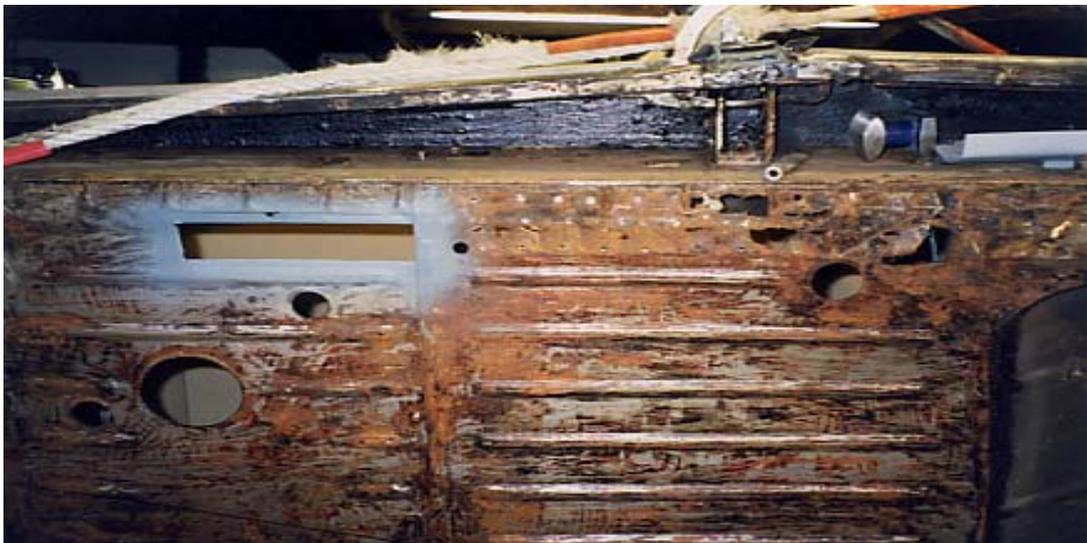
The corroded floor pan. Rusted parts were cut out and dealt with in sections. By welding in new metal in lengths of not more than a foot long, panel distortion was avoided. After cutting out the rust, the panel edges were primed with a Zinc rich weld-through primer, before new 18 gauge metal was Mig welded in. At the top of the picture you can just see the white tow rope to which the engine crane was attached.

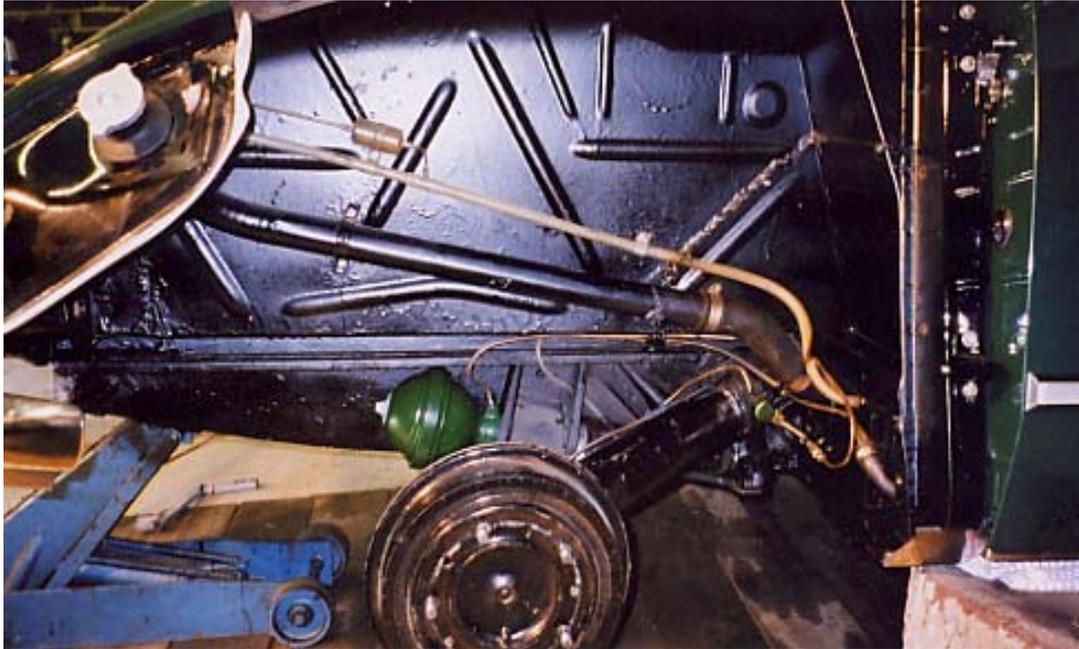
The restored offside rear wheel arch. The 'book' says there is 80 feet of hydraulic piping in the DS. I used just over 100 feet - but that included the learning curve of both forming nipples and bending the pipework neatly. All pipework is now in cupro-nickel and will not rust.

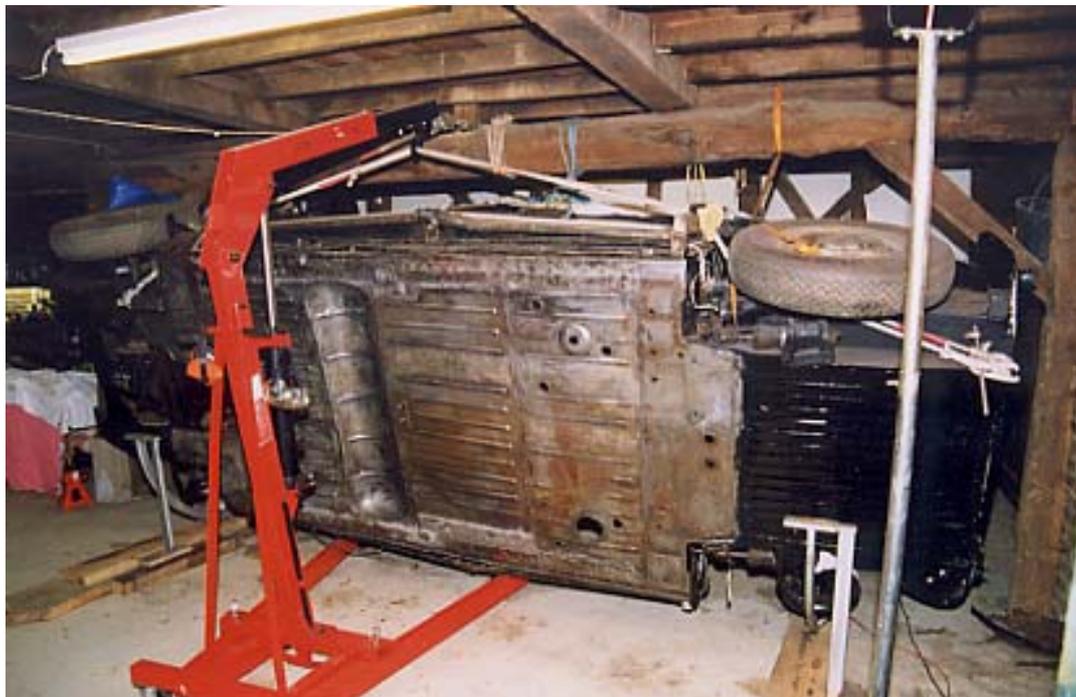
Welding on the floor pan now complete and painting underway, from the rear working towards the front. A 2-pack epoxy etching primer was used, followed by a coat of chassis black and finished with a sprayed coating of a flexible wax based underseal. All cavities were saturated with Waxoyl. The vertical aluminium tube in the foreground, is a portable Halogen floodlight.

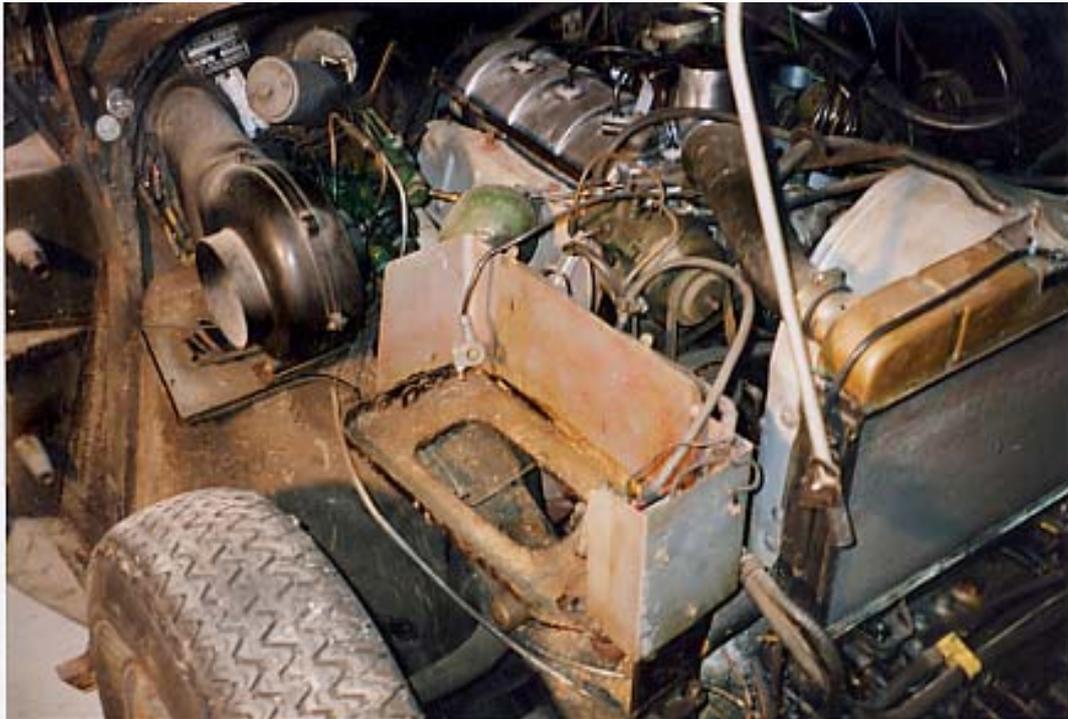
Work starts on stripping out the engine bay. On the '66 RHD Pallas, the battery is carried on the offside. The battery box was found to be heavily corroded and was largely rebuilt. When re-building the car, a battery mat (available from Frost) was used underneath the battery tray itself. This mat will absorb and neutralise any future acid spill.

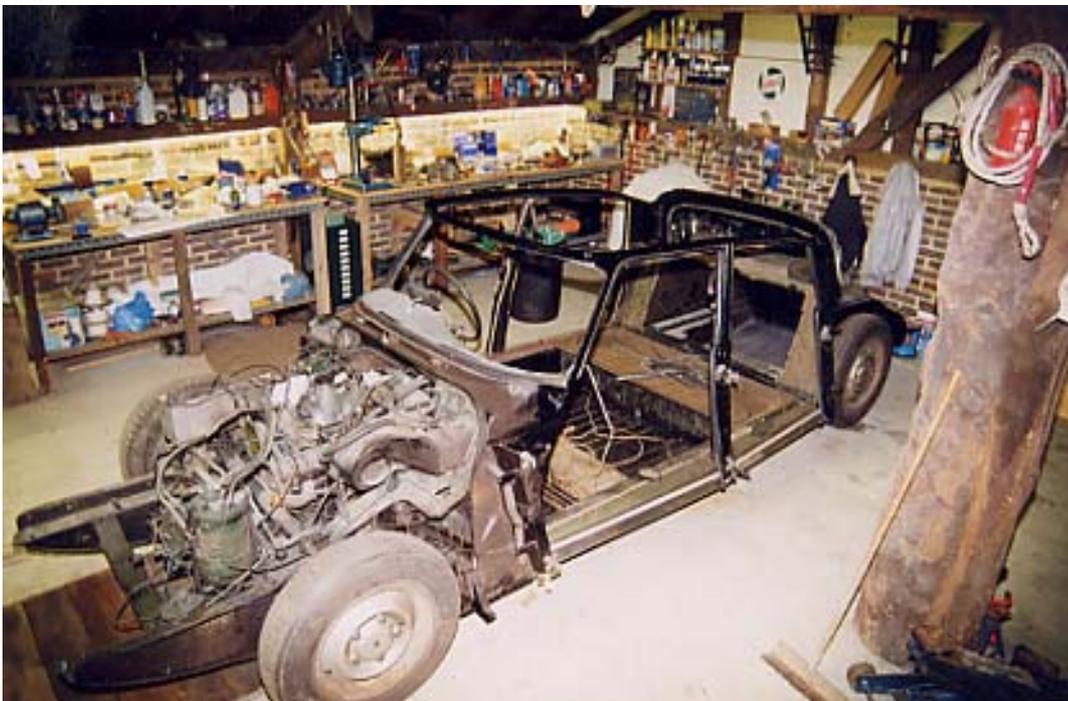
No new metal was needed in the roof rails. The roof rails were taken back to bare metal and re-painted again using a 2-pack etching primer. The opportunity was also taken of re-routing the aerial cable along a roof rail, down by the 'C' post, through the sill and up the 'A' post to the radio. Originally the cable ran up the windscreen pillar and could be seen.

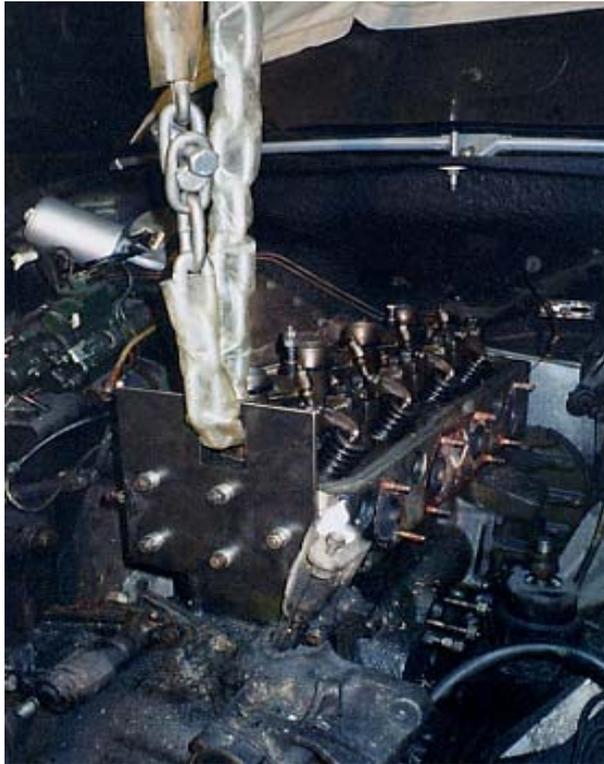
← To reduce the weight as much as possible; I was working single handed - all engine ancillaries were removed before the engine/gearbox assembly was removed from the car. I made up an engine hoist plate from mild steel and bolted it to the water pump studs. The engine came out surprisingly easily.

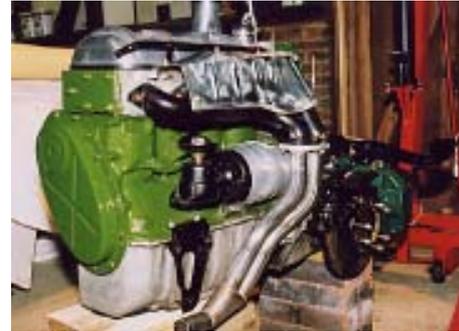
The restored engine waiting to go back in the car. The twin exhaust downpipes are now stainless steel; as are most fasteners used throughout the restoration.

The large circumference starter motor that is fitted to the '66 DS, makes it very difficult to remove, without first removing the exhaust downpipes. The (new) water pump and Citroën's own engine lift were fitted before the engine was put back in the car. →

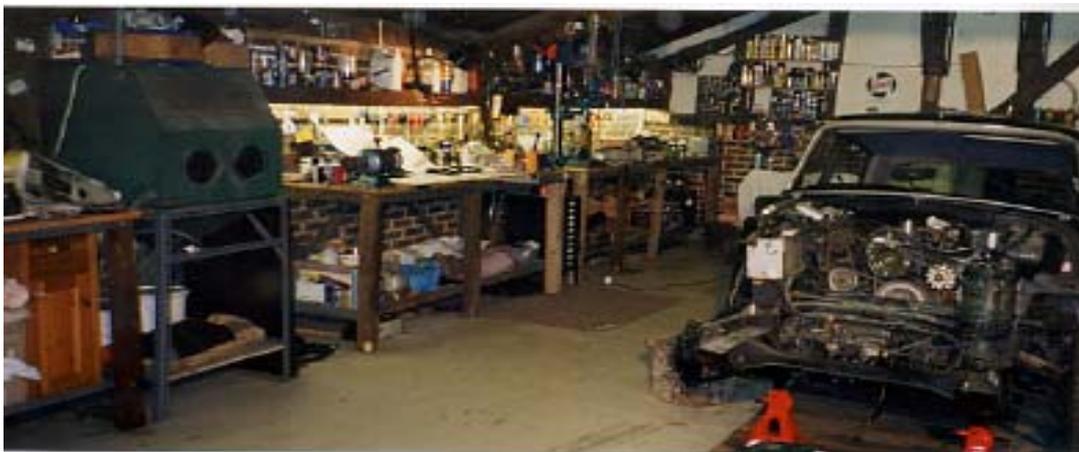
A general picture of my workshop. The cabinet in the foreground is my home made grit blaster. ↓

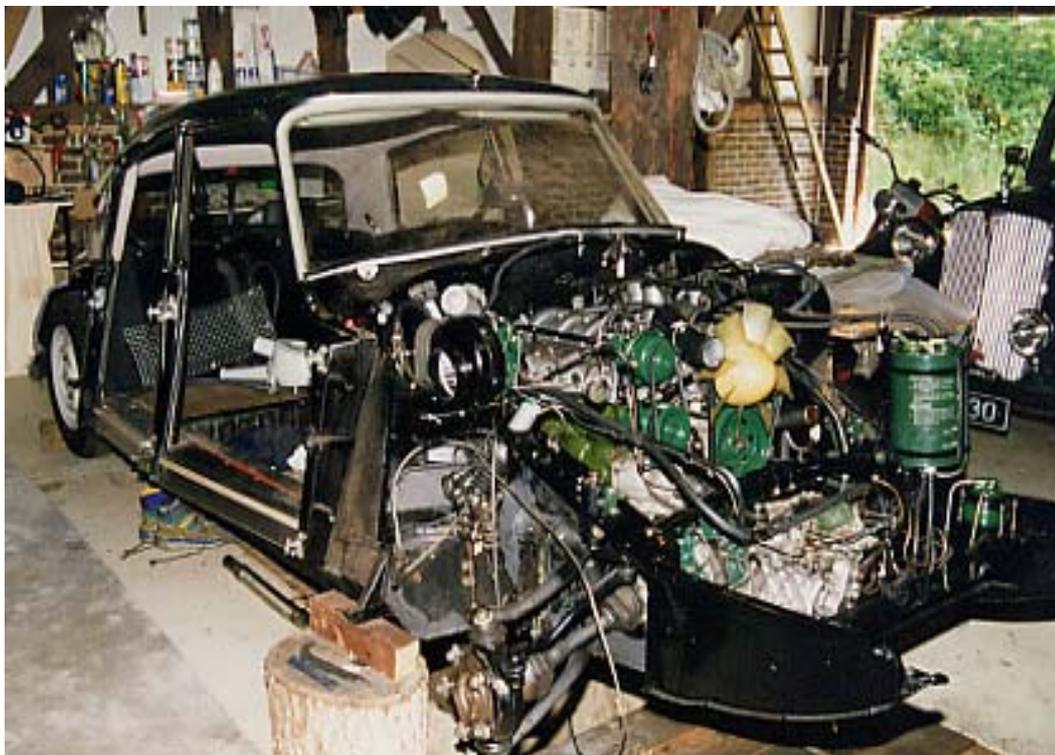
The engine gearbox assembly back in the restored chassis and ancillaries plus hydraulic units being re-fitted. Note that the car is supported each side by two tree trunks under the re-inforcing point. Underneath the car is a full length pit, which makes fitting things like the exhaust system so much easier. In the background is my 1946 Rover P2 14hp.

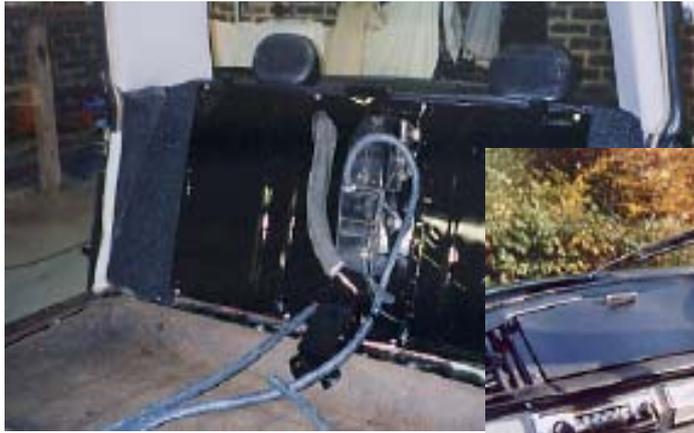
← My car has the optional cold weather rear heater unit fitted.

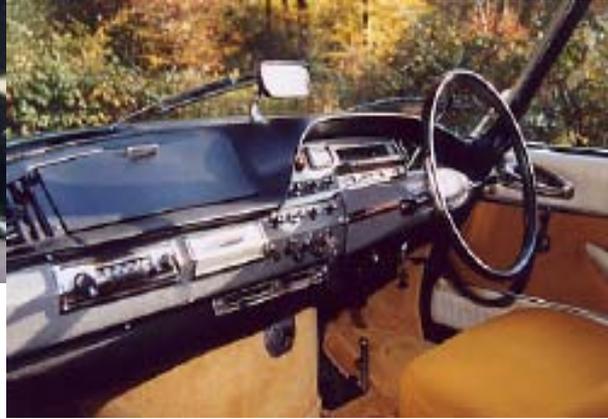
The restored dash. The upholstery is original. The Radiomobile radio is original, but has modern stereo FM innards. →

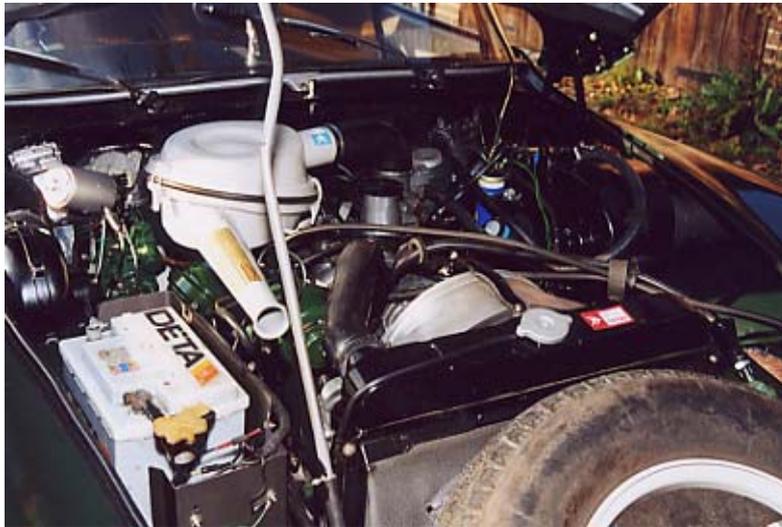
The restored engine bay. The battery has since been changed for a black one.

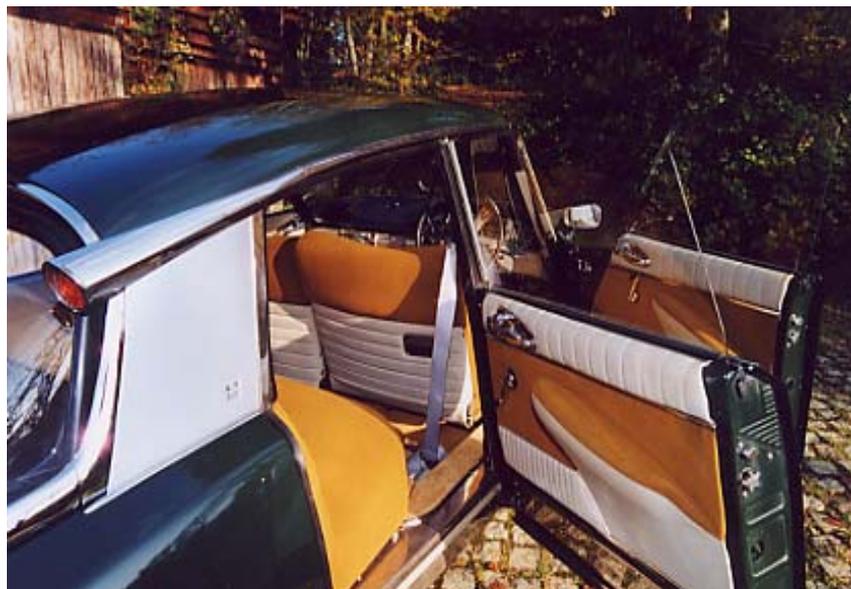
The restored interior. The carpet, to exactly match the original, was sourced from an Irish mill and made up by a professional carpet firm. That was probably the most expensive single bought-in item.
