Christmas Dinner in the Garage..... new exhaust manifold for the 15-Six!

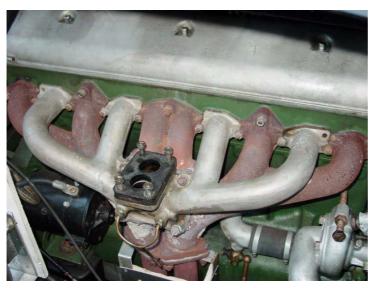
Right from the beginning a dark cloud hung over my head. The exhaust manifold on my 15-Six, bought a couple of years ago, was still one of the original type. It showed unmistakable traces of age but was still in one piece. "Optimists" (they call themselves friends...) assured me the thing would be short lived, estimates varying between a couple of hundreds to no more than 4 or 5000 km. I must admit that I have seen more broken original manifolds on Sixes, than intact ones and old dealers –speaking from experience- explained to me why in the old days they had to keep a stock of 15/6 exhaust manifolds just in case... It is highly unlikely, therefore, that the manifold on my car was the one fitted in the factory back in 1952. A quick glance at the CTA catalogue made me shiver!
